Manhole Inspection Summary

Manhole # S51C__040MH

Insp Date: **5/2/08 1:50 PM**

Location Address: **rear 36 north linwood ave** Cross Street: **e fairmount ave**

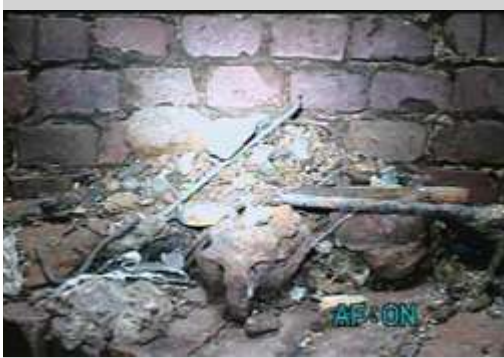
misc bench debris

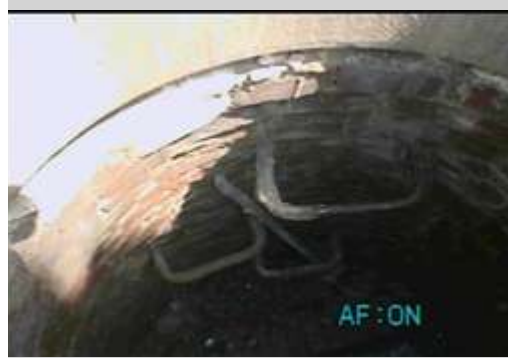
Defect 1

Condition: ☐ Sound ☐ Cracked ☐ Root Intrusion ☒ **Loose Brick** ☐ Deteriorated

Steps Count: **3** Missing: **0** ☒ **Corroded**

corroded steps, loose bricks in chimney

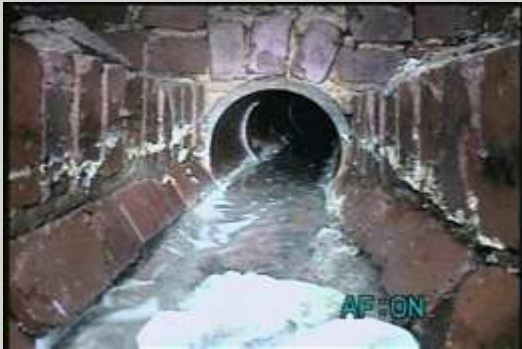
12 O'Clock Outflow

8 in. Circular Gravity Sewer
Pipe Out @ 12 O'Clock

Invert Depth: 11.45 (ft.) Flow Characteristics: **Fast**

Infiltration: **None** Pipe Seal Cond: **Unknown**

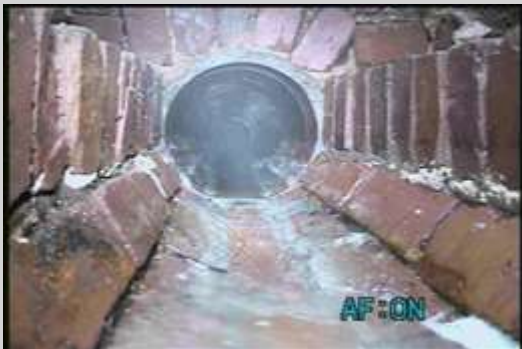
6 O'Clock Inflow

8 in. Circular Gravity Sewer
Pipe In @ 6 O'Clock

Invert Depth: 11.38 (ft.) Flow Characteristics: **Fast**

Infiltration: **None** Pipe Seal Cond: **Unknown**
